RUNWAY OVERRUN DURING LANDING  
AMERICAN AIRLINES FLIGHT 1420  
MCDONNELL DOUGLAS MD-82, N215AA  
LITTLE ROCK, ARKANSAS  
JUNE 1, 1999

**Runway Overrun During Landing  
American Airlines Flight 1420  
McDonnell Douglas MD-82, N215AA  
Little Rock, Arkansas  
June 1, 1999**

**NTSB/AAR-01/02  
PB2001-910402  
Notation 7195A  
Adopted October 23, 2001**

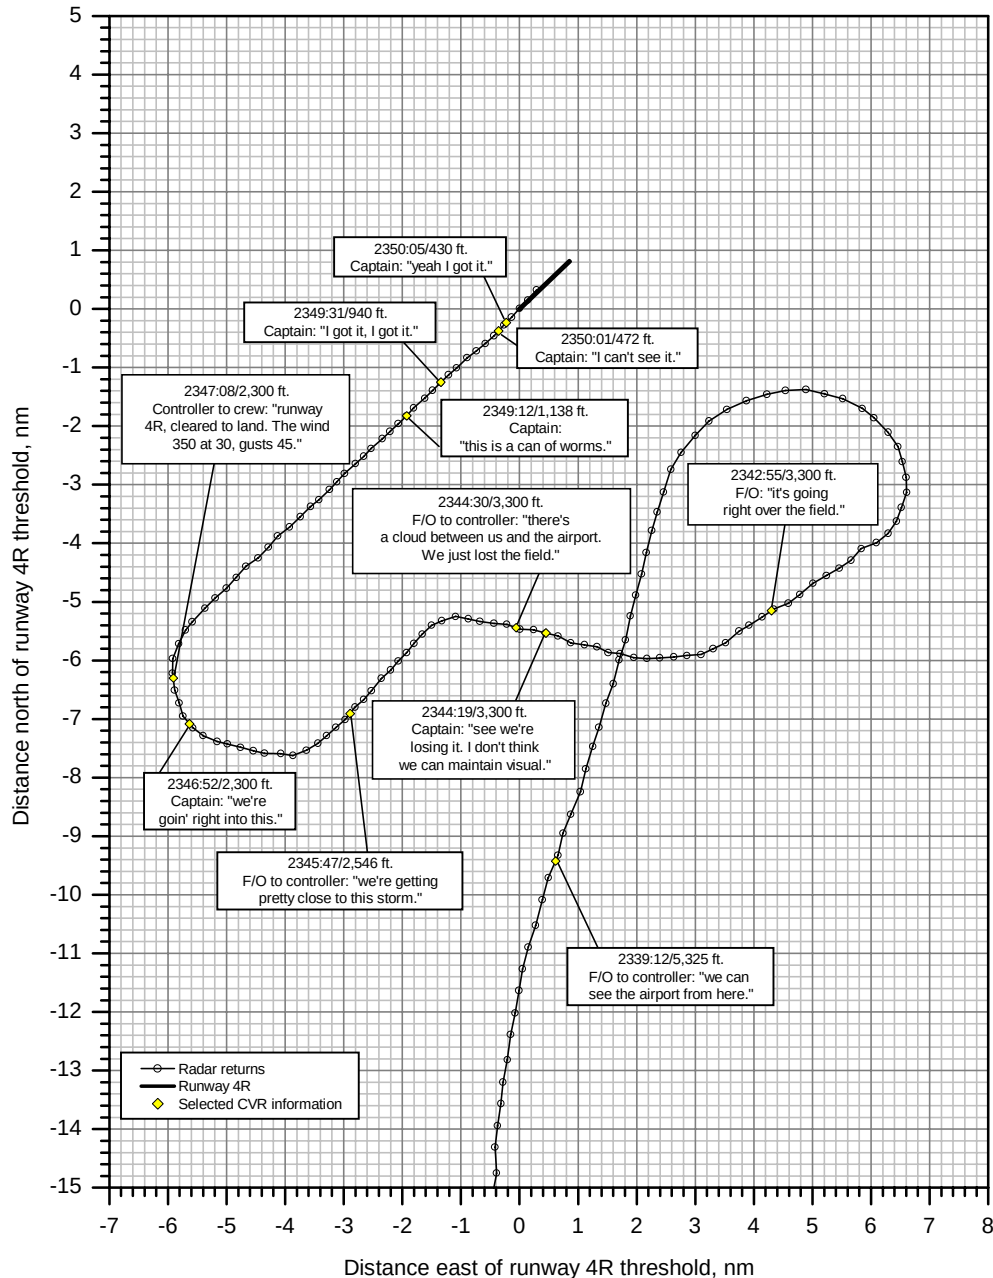
**Figure 1.** Flight 1420's Approach Path to the Airport and Key CVR Comments

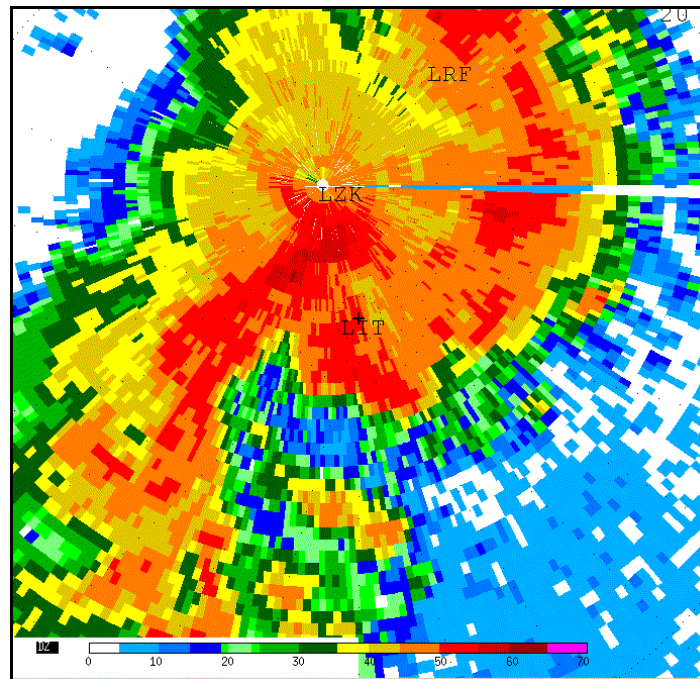
The WSR-88D's 0.4° elevation scan of base reflectivity that was completed at 2345:57 indicated that the area over the airport and the approach end of runway 4R reached reflectivities of 54 dBz, or level 5 (intense) activity, and that the area approximately 5 miles west of runway 4R reached maximum reflectivities of 61.5 dBz, or level 6 (extreme) activity. Figure 9 shows the base reflectivity product for this time period.

**Figure 9.** 0.4° Base Reflectivity Scan at 2345:57

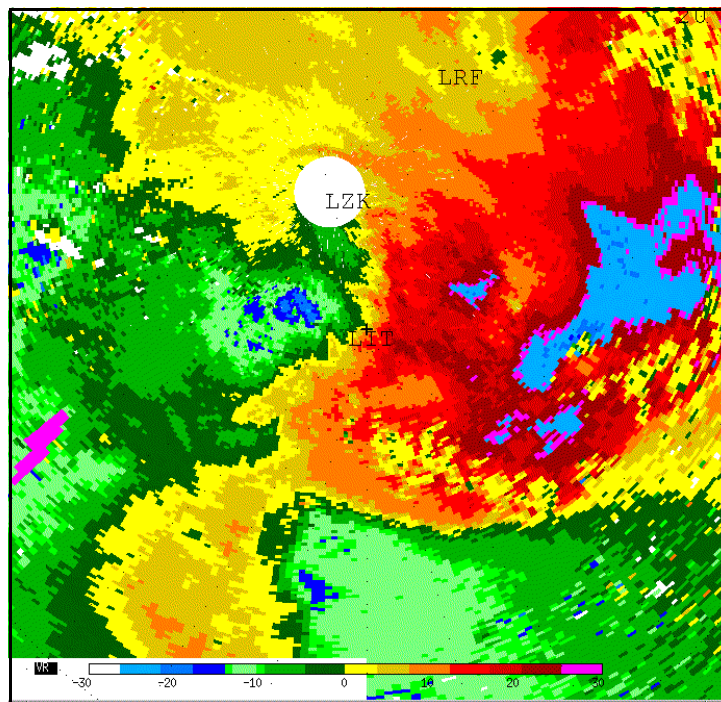
The WSR-88D's radial velocity image (showing components of the wind speed that are coming directly toward or away from the radar) for 2346:29 indicated that winds from the northwest at 15 meters per second (30 knots) were over runway 4R. Figure 11 shows the radial velocity image for this time period with the airplane's flight track. At 2352:30, the radial velocity image depicted winds from the northwest at 18 meters per second (36 knots) over the runway with winds reaching 30 meters per second (60 knots) within 1/2 mile of the approach end of the runway.

**Figure 11.** Radial Velocity Image Surrounding the Time of the Accident

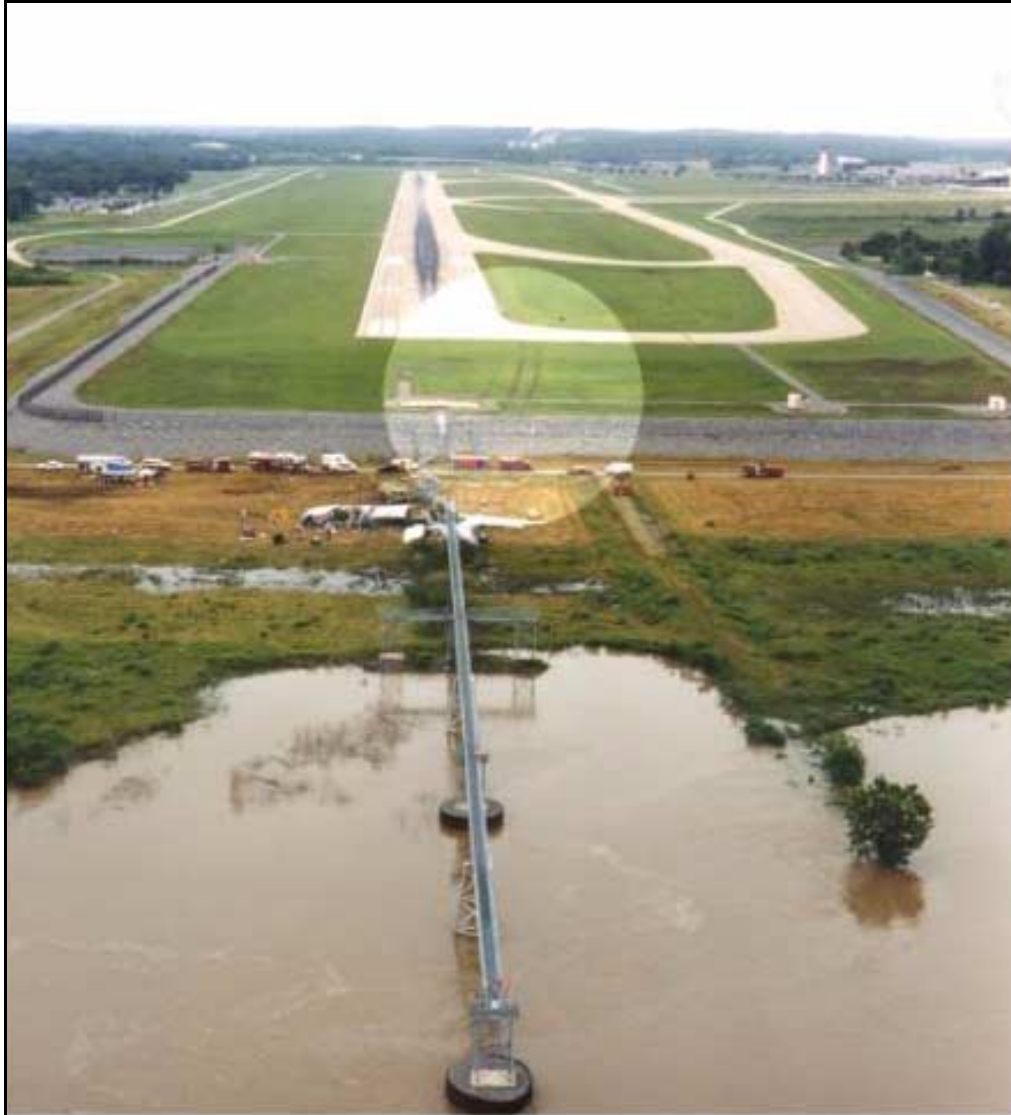
The airplane destroyed several tubes extending outward from the left edge of the runway 4R ILS localizer array, part of a chain link security fence, and approximately 250 feet of the runway 22L approach lighting system support structure and walkway. The damage was estimated at \$325,000.

**Figure 12.** Aerial Photograph of Runway 4R/22L, Airplane Wreckage, and Runway 22L Approach Lighting System

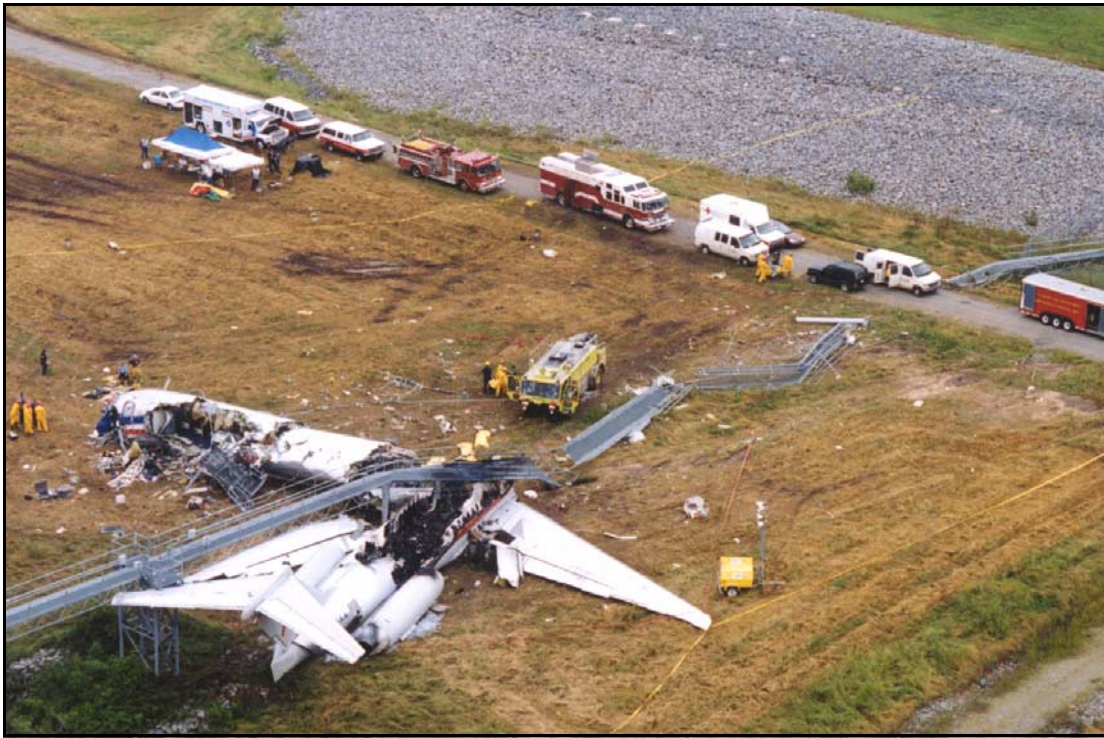
**Figure 13.** Airplane Wreckage and Runway 22L Approach Lighting System

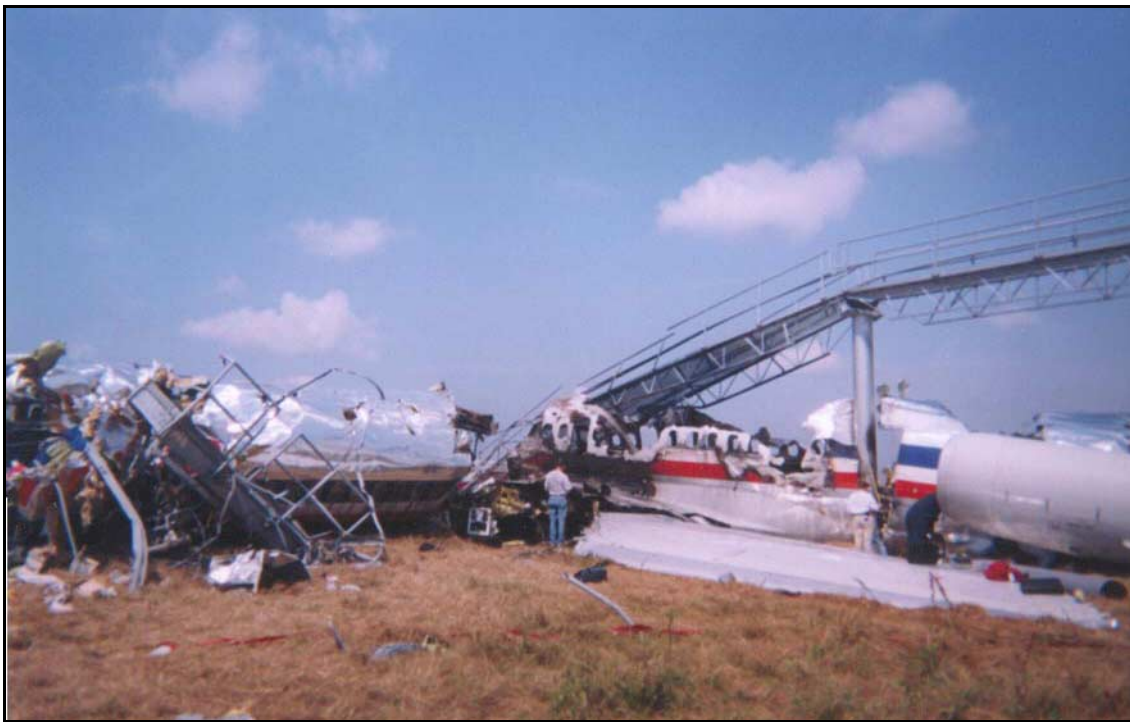
**Figure 14.** View of Left Side of Airplane Wreckage and Runway 22L Approach Lighting System

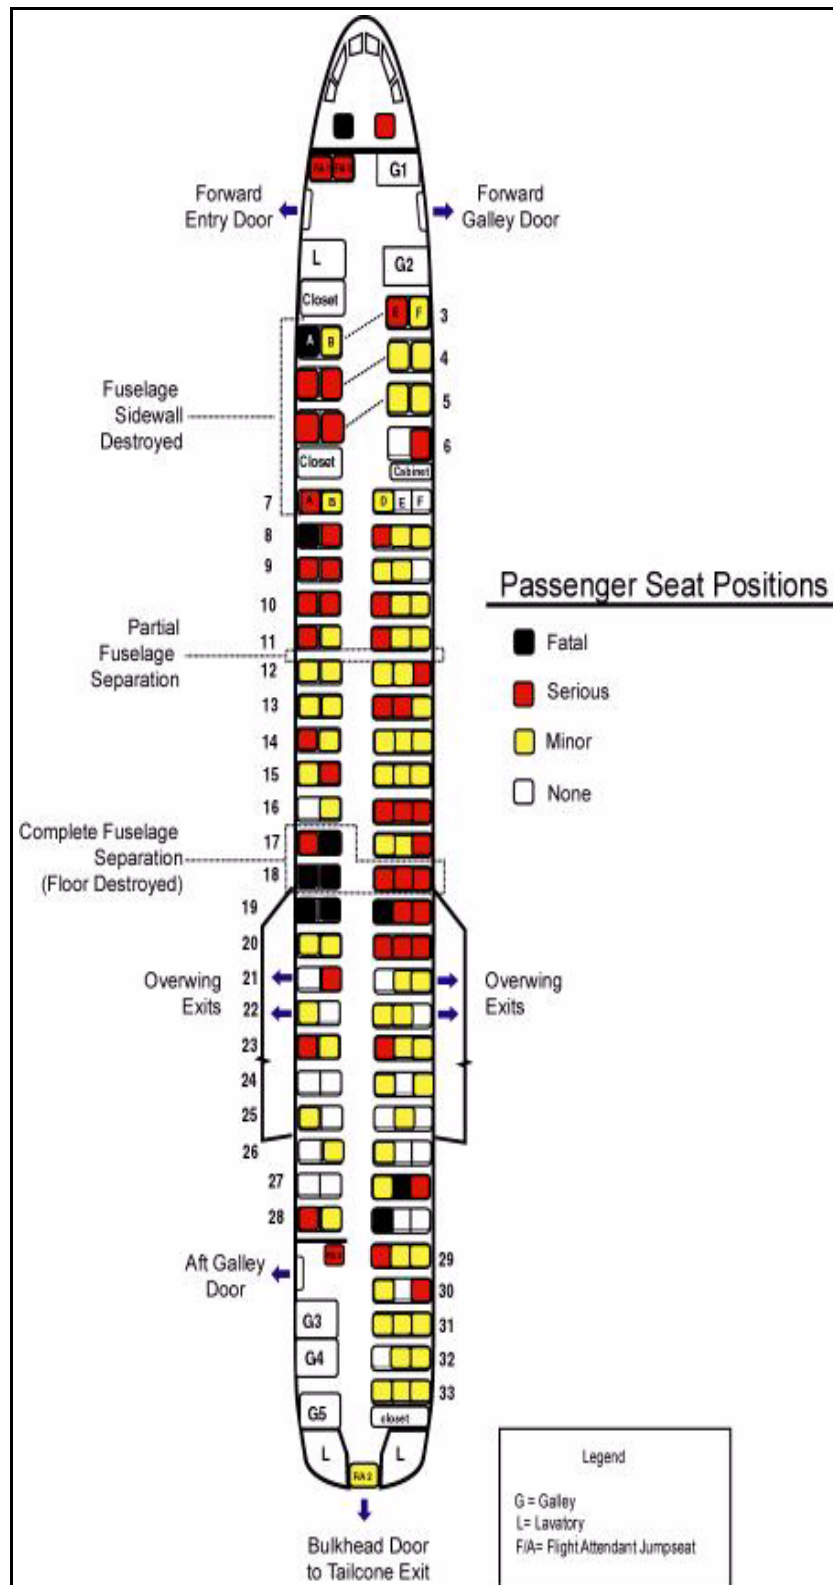
**Figure 15.** Interior Airplane Configuration and Occupant Injuries

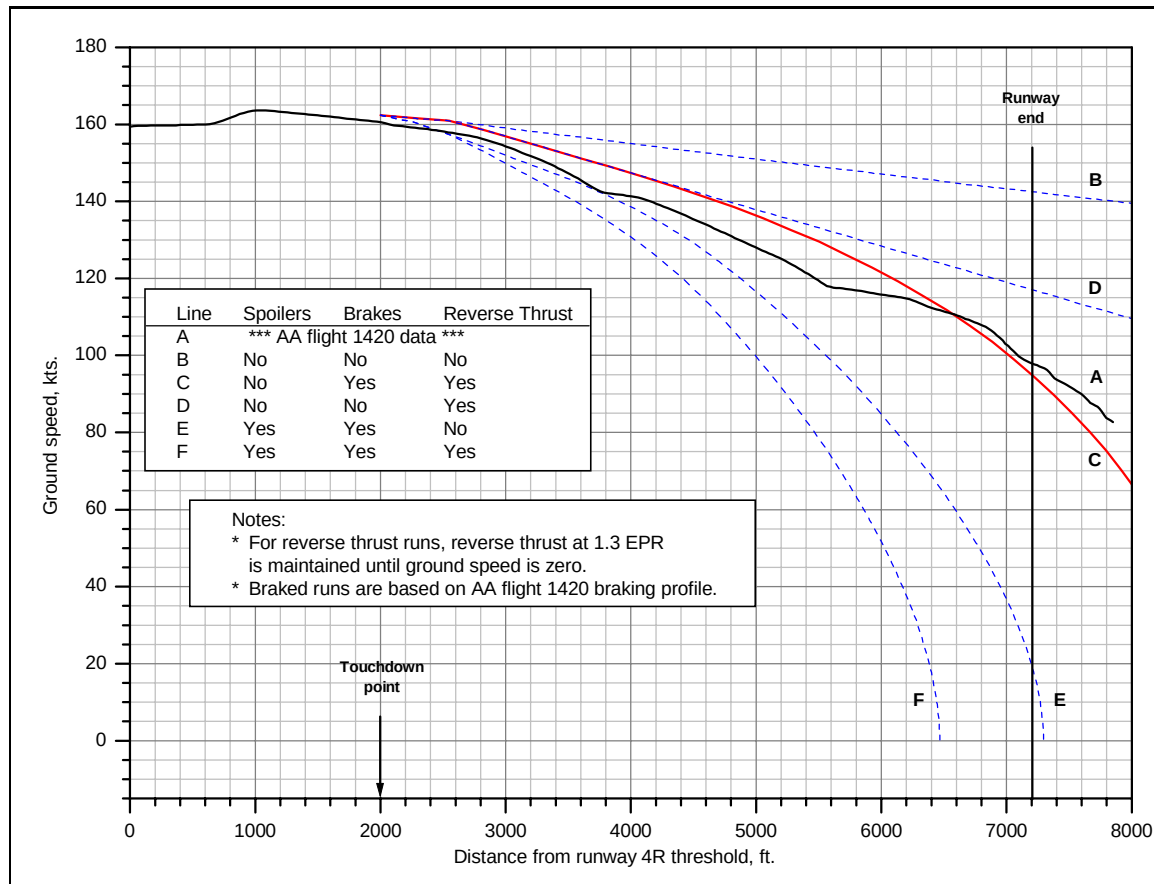
With no braking, spoilers, or reverse thrust, the airplane would depart the runway with a ground speed of about 142 knots, which is 45 knots faster than the flight 1420 airplane. With no spoilers or brakes but with a constant, symmetrical reverse thrust at

1.3 EPR, the airplane would leave the runway at 117 knots, which is 20 knots faster than the flight 1420 airplane. With no spoilers but with 1.3 EPR reverse thrust and the flight 1420 braking profile, the airplane would have departed the runway at 95 knots. This computer run matched the flight 1420 data best and indicated that the accident airplane experienced a braking coefficient of at least 0.21 to 0.23 at speeds between 160 and 140 knots, respectively.<sup>96</sup> Figure 16 shows the results of the computer runs compared with the flight 1420 profile.

**Figure 16.** Effects of Spoilers, Brakes, and Reverse Thrust on Stopping Distance

Two additional computer runs demonstrated that proper spoiler deployment is critical to deceleration and stopping distance. Without reverse thrust and with the spoilers deployed and the flight 1420 braking profile, the airplane would depart the runway at 20 knots, which is 75 knots less than the airplane with no spoilers but with reverse thrust and braking. With constant reverse thrust, deployed spoilers, and the flight 1420 braking profile, the airplane could have stopped about 700 feet before the end of the runway.

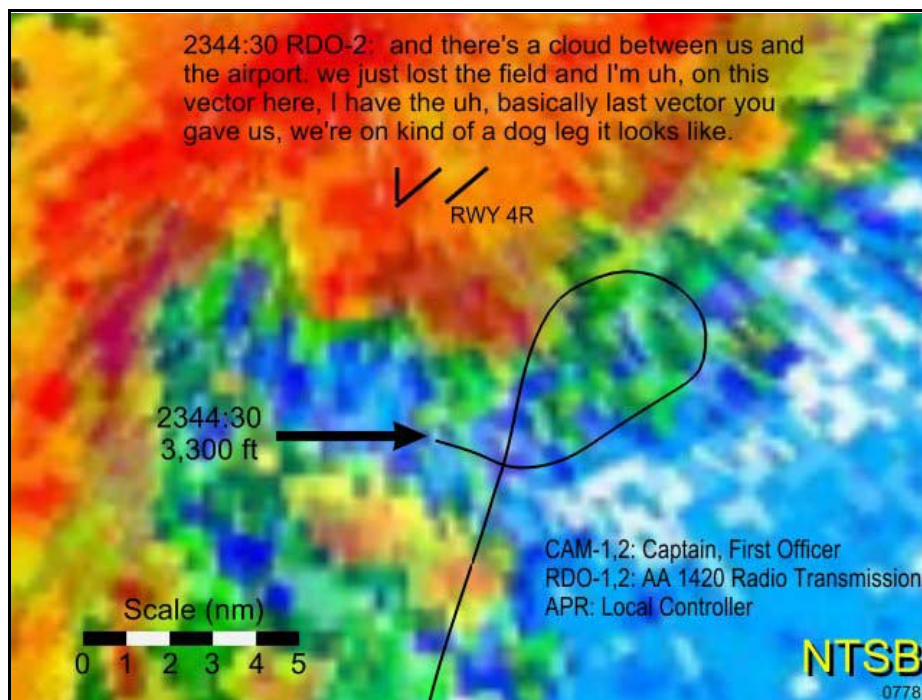
At 2344:19, the captain stated, "see we're losing it. I don't think we can maintain visual." The first officer notified the controller at 2344:30 that visual contact with the airport had been lost because of a cloud between the airplane and the airport. The controller then cleared the airplane to fly a heading of 220° for radar vectors for the ILS approach to runway 4R. (ATC radar indicated that, at this time, flight 1420 was about 6 miles south of runway 4R, heading westbound and away from the runway. Weather radar data indicated that heavy rain was occurring at the airport at the time that the airplane was flying on the 220° heading.) Figure 21 shows a map of the weather conditions at 2344:30 and flight 1420's location.

**Figure 21.** Weather and Flight Information for 2344:30

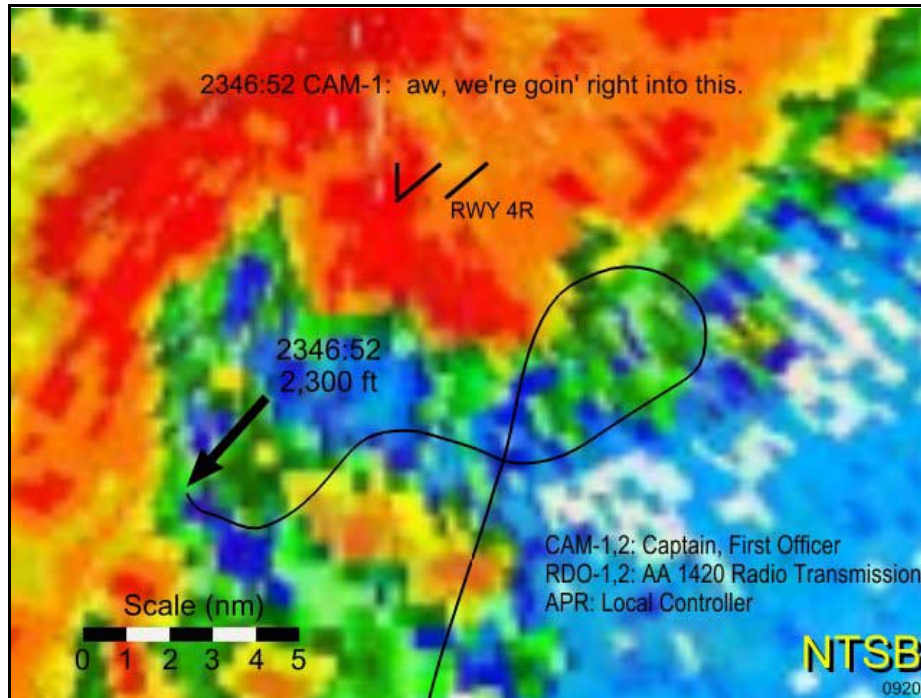
At 2346:52, the controller advised the flight crew that heavy rain was falling at the airport, visibility was less than 1 mile, ATIS information Romeo was no longer current, and the runway visual range (RVR) was 3,000 feet. Simultaneously, the captain

stated, “aw, we’re goin’ right into this.” Figure 23 shows a map of the weather conditions at 2346:52 and flight 1420’s location. About this point in the approach, the flight crew should have regained the use of the airborne weather radar to depict precipitation levels in front of the airplane. However, the Safety Board could not determine whether the radar was displaying this information or whether the flight crewmembers, given their workload, were able to perceive and interpret the information that the radar was providing.

**Figure 23.** Weather and Flight Information for 2346:52

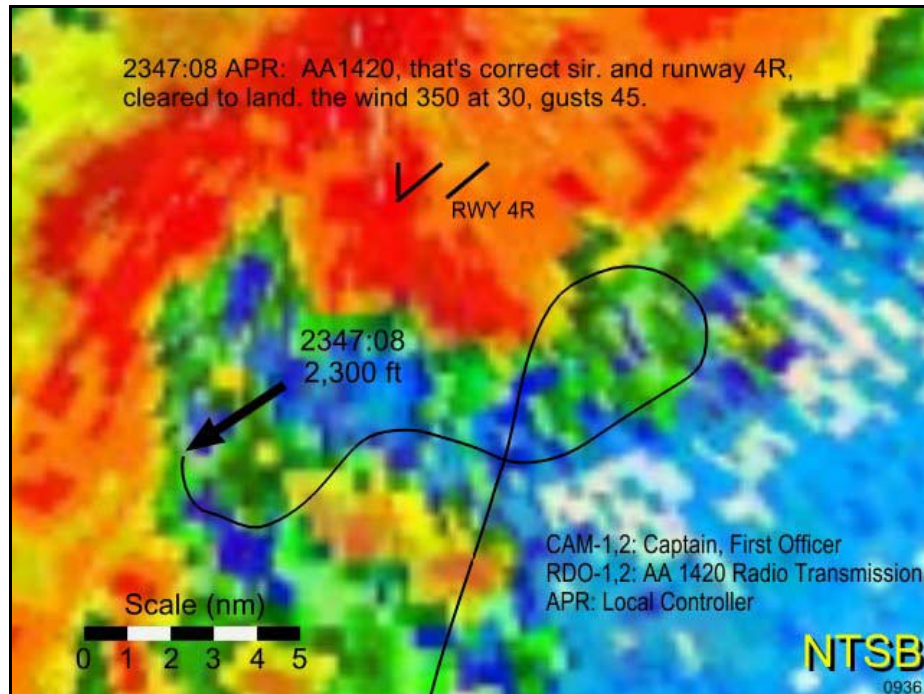
At 2347:08, the controller cleared flight 1420 to land and stated that the wind was 350° at 30 knots gusting to 45 knots. The CVR indicated that flight crew did not discuss the wind information, the heavy rain that was already falling at the airport, or the depiction of the weather on the airborne weather radar. Figure 24 shows a map of the weather conditions at 2347:08 and flight 1420’s location.

Statements from the CVR and the first officer’s postaccident interviews indicated the flight crew’s concern about the location of the thunderstorm in relation to the airport and the airplane. However, the Safety Board concludes that, because the first officer was able to maintain visual contact with the runway as the airplane was vectored for the final approach course, both flight crewmembers might still have believed that flight 1420 could arrive at the airport before the thunderstorm. The Board understands that some other flight crews might continue an approach to a runway under the same circumstances. On the other hand, the Board also recognizes that the approaching storm and the reports of heavy rain, dropping visibility, and increasing crosswinds (from 10 to 30 knots with

gusts to 45 knots) would be sufficient for some flight crews to hold until the storm passed or proceed to an alternate airport.

**Figure 24.** Weather and Flight Information for 2347:08

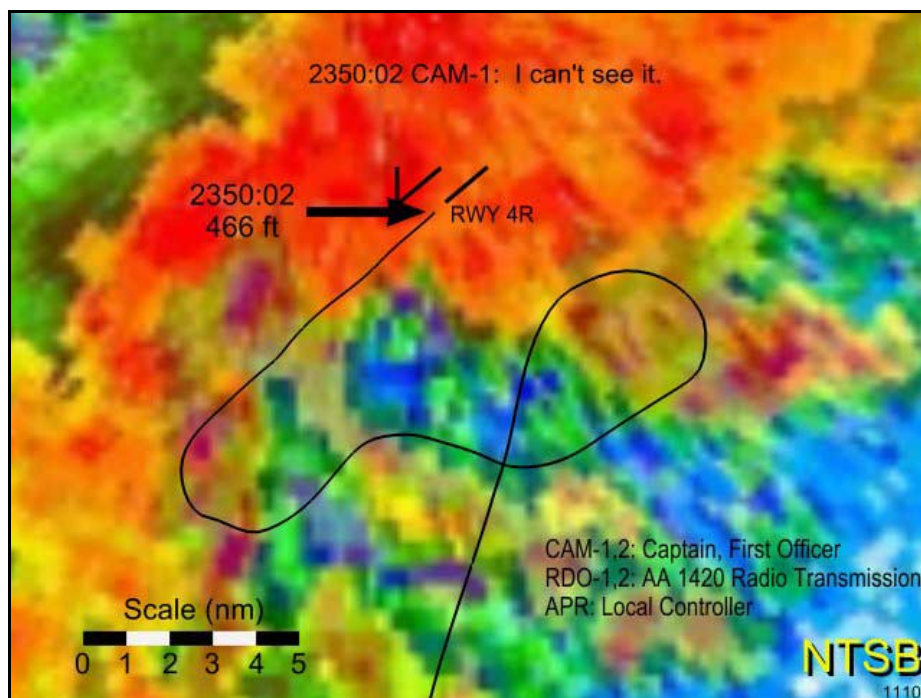
At 2350:02, the captain stated, "I can't see it." Calculations based on FDR data indicated that the airplane was between 5 and 20 feet above the decision height at that time. The Safety Board was not able to determine whether the captain's comment referred to his loss of visual contact with the runway or with its environment. Figure 26 shows a map of the weather conditions at 2350:02 and flight 1420's location.

**Figure 26.** Weather and Flight Information for 2350:02
