# COMMUNICATIONS FAILURE IN HYATT REGENCY DISASTER

By Elizabeth A. Banset<sup>1</sup> and Gerald M. Parsons<sup>2</sup>

**ABSTRACT:** In July, 1981, two suspended walkways overlooking the lobby of the Hyatt Regency Hotel in Kansas City, Mo., collapsed, killing 114 people and injuring 200 more. The immediate cause of the accident was a structural design flaw in the box beam-hanger rod connections supporting the walkways. However, a more fundamental cause was a series of communication failures between the structural engineer and the steel fabricator. Confusion developed about whether the fabricator was to assume the professional role of "designer" or "developer," design drawings failed to clearly communicate important design information to indicate that the box beam-hanger rod connection shown was an "incomplete" design, and ambiguities in communicating intent were never resolved—all contributing to the ultimate tragedy. Specific areas of miscommunication that led to the inadequate box beam-hanger rod design that made the structural collapse inevitable are examined. The purpose is twofold: (1) To provide some insight into the complexities of communication systems in the constructio

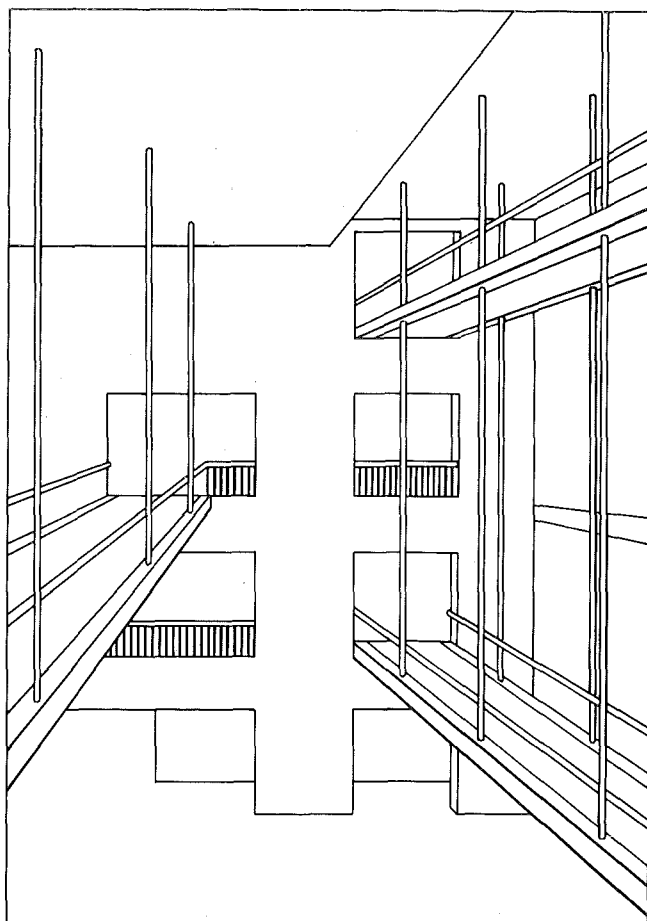
The Hyatt Regency Hotel was designed in three sections: (1) A 40-story tower section to the north; (2) a function block to the south; and (3) a connecting atrium. Three 120-ft suspended walkways spanned the 50-ft high atrium area, connecting the tower section and the function block. Two walkways were constructed on the west side, at the second and fourth floor levels, and one on the east side, at the third floor level. (See Fig. 1.)

**FIG. 1. View of Hyatt Regency Atrium Looking South (Adapted from Pfrang and Marshall 1982)**

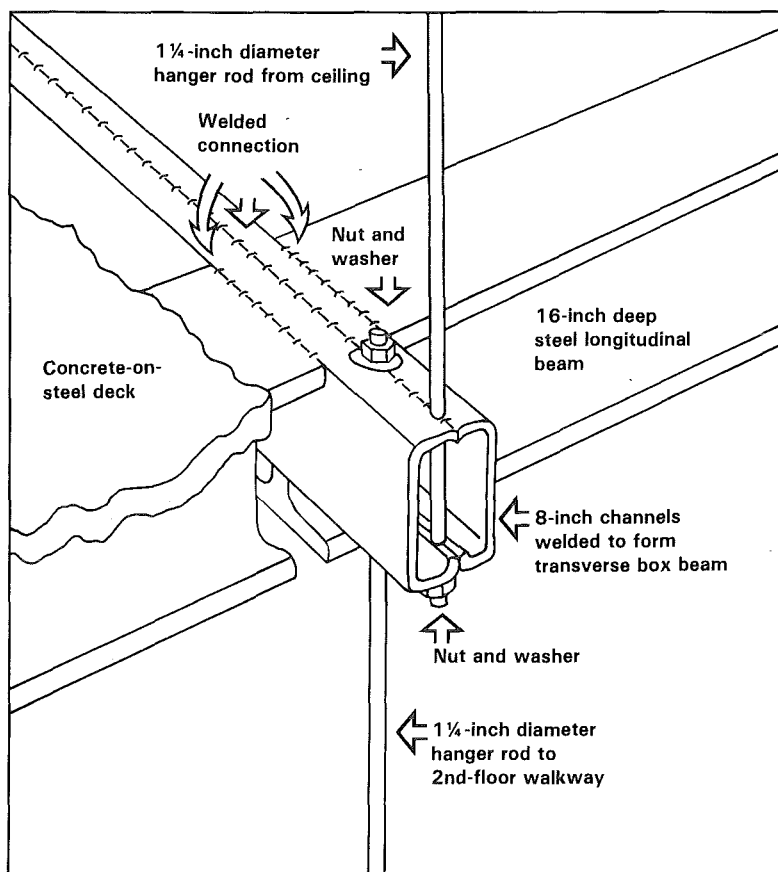
**FIG. 2. Typical Fourth Floor Box Beam-Hanger Rod Connection (Adapted from "Hyatt Walkway Design Switched" 1981)**

second floor walkway by extending downward through a hole in the second floor box beam, terminating with a nut and washer on the beam's underside (Pfrang and Marshall 1982; "Hyatt walkway design switched" 1981). Fig. 2 shows a typical fourth floor box beam-hanger rod connection.

The collapse involved the second and fourth floor walkways and occurred during an early evening Tea Dance that took place in the hotel's atrium area. The walkways fell to the atrium floor, with the fourth floor walkway coming to rest atop the second. Investigators concluded that the structural failure began at the east end of the middle box beam on the fourth floor walkway. The bottom weld on the box beam at the hanger rod connection broke, allowing the box beam to slip down over the nut and washer at the lower end of the floor-to-ceiling hanger rod. This led to the failure of the other fourth floor box beam-hanger rod connections. Because the fourth floor walkway

supported the hanger rods for the second floor walkway, it, too, collapsed when the fourth floor box beams gave way.

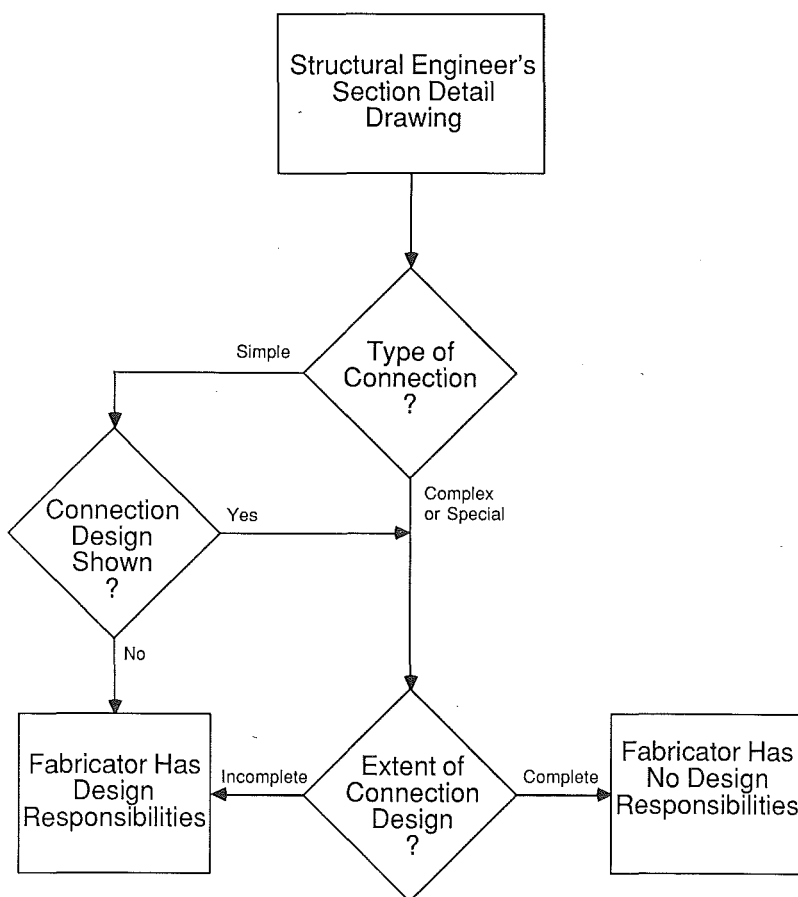
**FIG. 3. Communication of Design Responsibility from Structural Engineer to Steel Fabricator**

Fig. 3 illustrates in flow chart form the process the steel fabricator goes through to determine what role to play in connection design. The fabricator's
