# CHRONOLOGY AND CONTEXT OF THE HYATT REGENCY COLLAPSE

By Gregory P. Luth<sup>1</sup>

**ABSTRACT:** This paper presents a brief chronology of the events that preceded the collapse of the walkways at the Kansas City Hyatt Regency Hotel, including the prior failure that occurred during construction and the evolution of the detail that caused the catastrophe. Many of the facts surrounding the case were not publicized, due to the litigation. Some were not brought out during the litigation. No attempt will be made to affix responsibility, as these issues were resolved years ago. The chronology is followed by a discussion of the events that contributed to the collapse and of the changes that have been made in the industry toward preventing a similar occurrence.

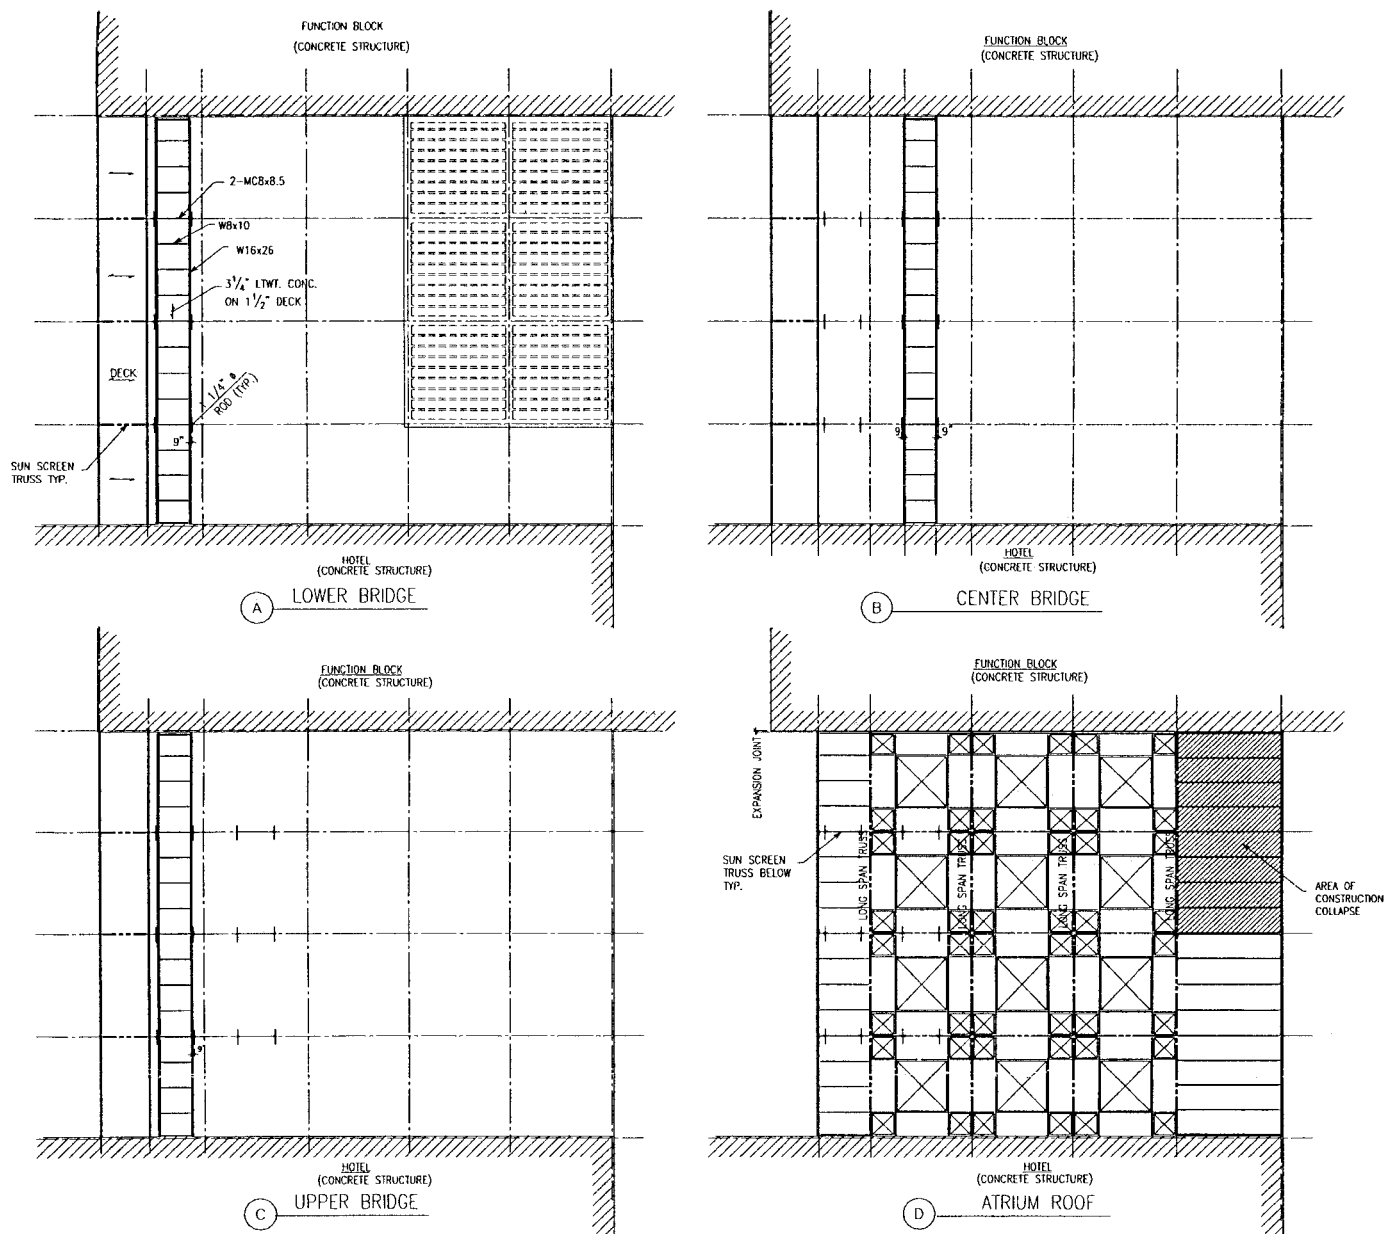
FIG. 1. Floor Plans of Roof and Walkways at Kansas City Hyatt

The detail was cross-referenced at all three floors where the walkways connected to the hanger rods. The dimensions on the plans (Fig. 1) indicated that the hanger rods between the 2nd and 4th floors were in the same location, implying a continuous hanger rod. At the 4th floor the detail was shown as "SIM," indicating in industry shorthand that while there were differences in the details they were the same in all essential respects.

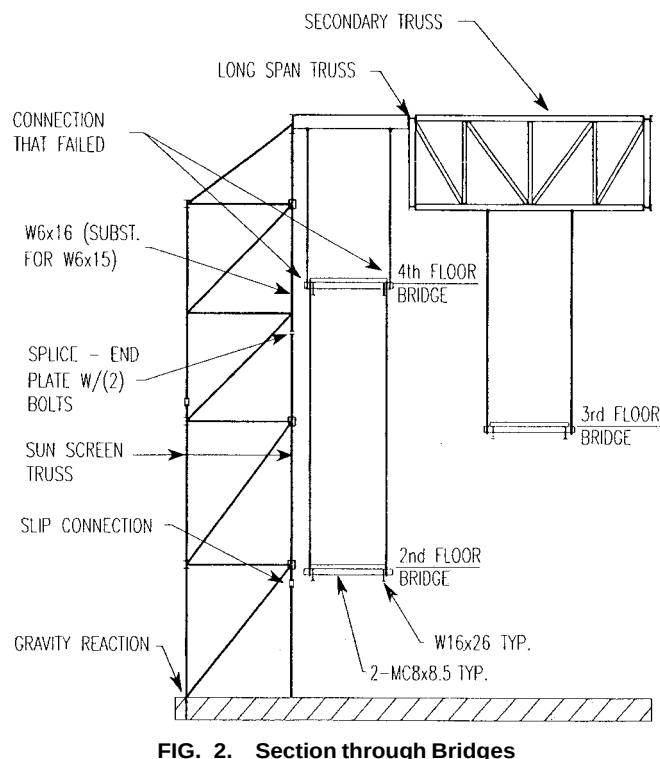
FIG. 2. Section through Bridges

Production of construction documents was ongoing between July 1977 and January 1978. Because of architectural constraints, the sunscreen structure evolved into a vertical truss that picked up loads at the roof on one chord and dropped them off at the first floor at the other chord in order to avoid loading the concrete floor system at the first floor. The inside chord of the sunscreen truss, which functions as a column, was designed to be provided with lateral support by structural tubes that also supported the curtain wall. Early schemes called for the walkways to be supported on posts off of the concrete floor at the first level. Later, the decision was made to suspend the walkways from the roof structure to give a light and airy feel to the atrium space. Fig. 1 shows floor plans of the roof and walkways; Fig. 2 shows a section through the screen wall and bridges.

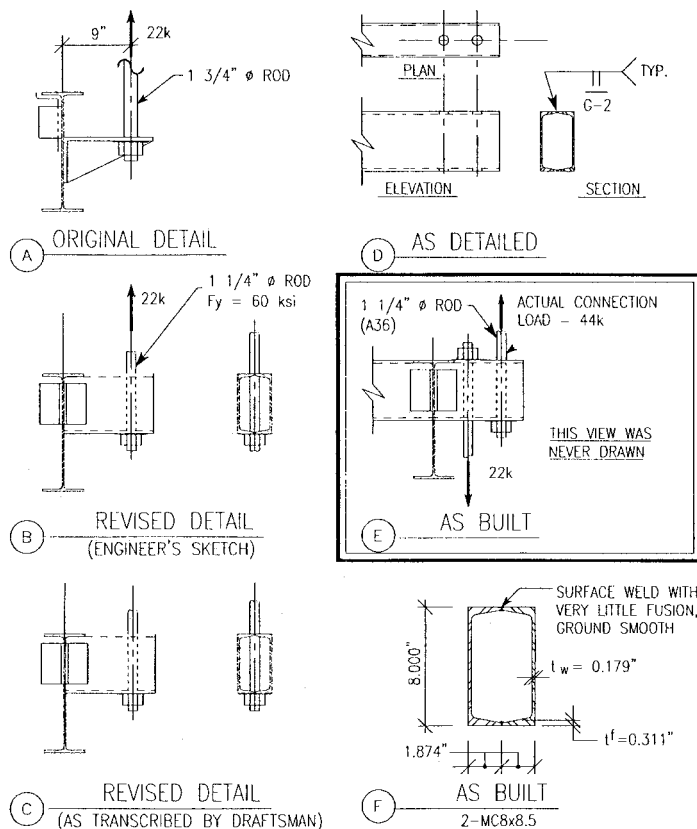
FIG. 3. Evolution of Walkway/Hanger Rod Connection

The draftsman transcribed the detail onto the contract drawings, as shown in Fig. 3(c). Note the information that is missing. Neither the yield strength nor the load is indicated on the detail. The series of events that led to the change in the detail from Fig. 3(a) to Fig. 3(c) were the first steps down the road to tragedy.

The weld symbol on the shop drawings indicated a groove weld between the toes of the channels ground flat. In reality, the dimensions that were used in detailing did not allow for a gap. The shop butted the two flanges together and a surface weld was applied to the outside of the two flanges. A bead was run on the interior of the channels as far back as the welder could reach with his stinger, although this was not explicitly called for on the shop drawings and was not required. The outside weld was ground smooth, leaving a razor-thin sliver of weld metal [Fig. 3(f)].

The as-built connection at the 4th floor bridge is shown in Fig. 3(e). This detail was never drawn, either on the shop drawings or the design drawings. In fact, the connection was never drawn or designed. The engineer assumed that the original single-rod connection would be designed by the fabricator, consistent with the standard practice at the time, for the force indicated on his detail. Because of a drafting error, that force was not on the design drawing. The change to two offset rods had the effect of doubling the connection force from 22 kips to 44 kips.

The change also resulted in two holes through the 100 mm (4 in.) wide box beam. The inner hole isolated the outer hole, limiting the effective length of weld that would be available to resist the concentrated reaction. The fabricator put the upper rod, which had double the reaction, on the outside hole. No stiffeners were provided and no closure plate was provided at the end of the box beam. The holes through the box beam were drilled after welding the two channels together. A standard washer was provided under the nut.

The local failure mechanism was similar at all of the 4th floor connections. Prior to the collapse, the reaction of the rod was carried by the flange of the box beam to the webs. The flange acted as a continuous beam, with both positive and negative moments under the concentrated force from the rod. The weld on the flange bearing on the upper rod ruptured, relieving the midspan moment, forcing the flanges to cantilever off of the 5 mm (3/16 in.) webs. The webs, which were likely in a yielded condition under the self-weight of the bridges, were incapable of resisting the overload; a plastic hinge formed, and the flanges rotated up until the nut and washer slipped through the resulting gap. A similar failure mechanism formed when the upper flange of the box beam hit the nut and washer, although by that time the momentum of the bridge carried it through the failure almost instantaneously.
