# ENGINEERING PROCESS FAILURE—HYATT WALKWAY COLLAPSE

By Piotr D. Moncarz,<sup>1</sup> P.E., Fellow, ASCE, and Robert K. Taylor,<sup>2</sup> P.E.

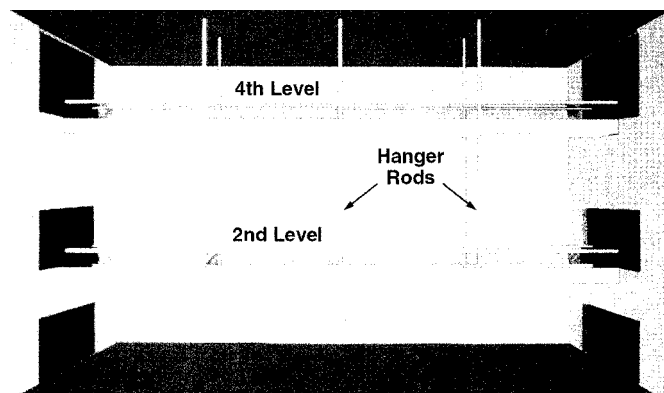
FIG. 1. Two Suspended Walkways Spanning Hotel Atrium

The failure of the connection between the hanger rod and the box girder is well documented through the physical evidence. The deformed end-connections of the upper bridge box beams clearly indicate hanger pullout. The east side rods (in the foreground of Fig. 1) suspended from the ceiling of the atrium were straight and vertical after the failure, while the west side rods had an inclination. This suggested hanger pullout initiation on the east side of the upper bridge. The central of the three east side connections showed the most symmet-

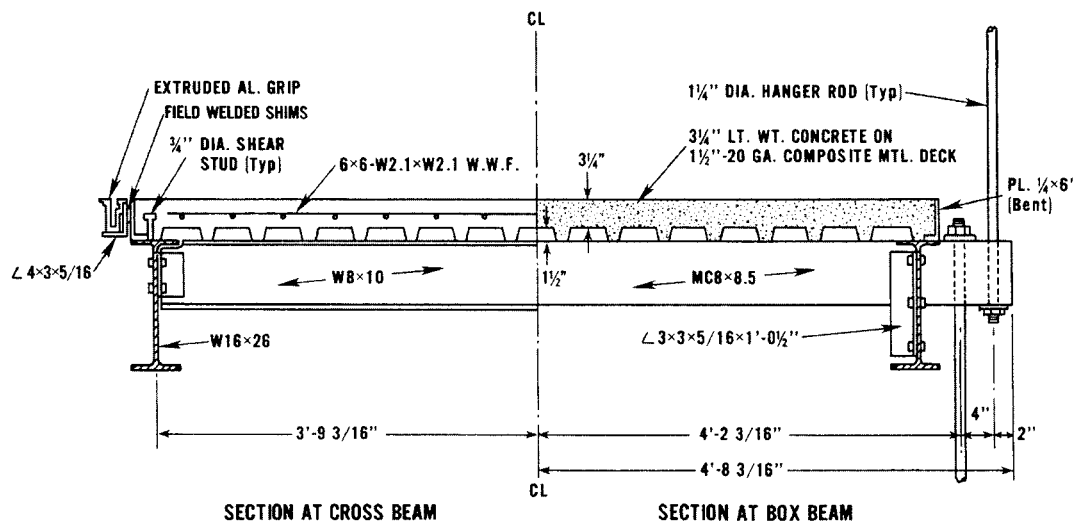
Fig. 3 provides a typical transverse section of the walkway deck. The deck was formed of lightweight concrete placed over a corrugated metal deck and was supported by two longitudinal I-beam stringers, W16  $\times$  26, which in turn transferred the weight of the bridge and the superimposed live load to three transverse box beams per bridge. The transverse box beams were assembled of two welded flange-to-flange channel sections, MC8  $\times$  8.5. The 32 mm (1 1/4 in.) diameter hangers passed through a hole in the channel flanges and carried the weight transferred by them through a nut and washer installed on the threaded hanger underneath the girder. For the bridges positioned in the same vertical plane (Fig. 1), the lower and upper bridges were suspended by the hanger attachment to the roof truss. Thus, the upper hanger carried the loads of both bridges, whereas the lower hanger carried only the load of the lower bridge. The contact area between the hanger rod washer and weld at the toe of the channels (Fig. 3) was ground down for flatness, thus further reducing the connection between the channel flanges.

FIG. 3. Typical Transverse Section of Walkway

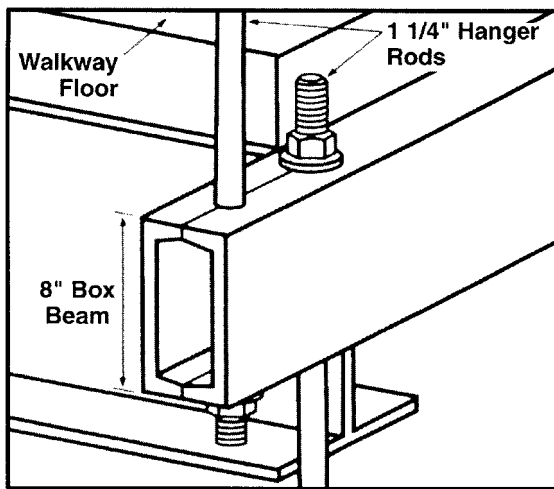
FIG. 4. As-Built Connection

nut through two stories seemed to be highly impractical. Thus, the contractor suggested a change to the drawing whereby each single hanger rod would be replaced by two rods: one going from the lower to the upper bridge, the second going from the upper bridge to the roof truss (Fig. 4). The dramatic impact of this change is shown in Fig. 5. The loads transferred through the contact between the upper bridge box beam and the nut and washer assembly had approximately doubled in the new arrangement. Instead of the force being equal to the tributary load of the upper bridge only, it became the sum of the tributary portion of both the upper and lower bridges.

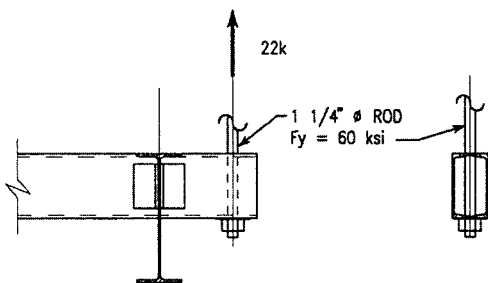
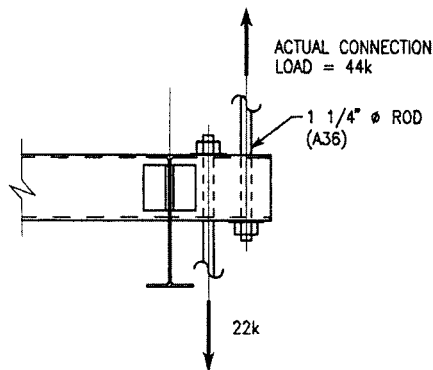
FIG. 5. Fatal Connection Evolution

Engineers Sketch

As-Built

While the key contributor to the failure—the change of the end connection detail as depicted in Fig. 5—was quickly identified, significant effort was expended to quantify the effect of other existing or potential contribution causes. Initial discussions speculated as to the impact of vibrations caused by the onlookers standing on the bridges and rhythmically moving to the tune of the music. Questions were raised as to the importance of additional concrete used in leveling the floor of the walkway, the size and quality of the box beam flange weld connection, and even the strength of the washers under the nuts.

- The Hyatt walkway collapse was a direct result of doubling the load on the suspension hanger rod-to-box beam connections through a change in the construction detail.

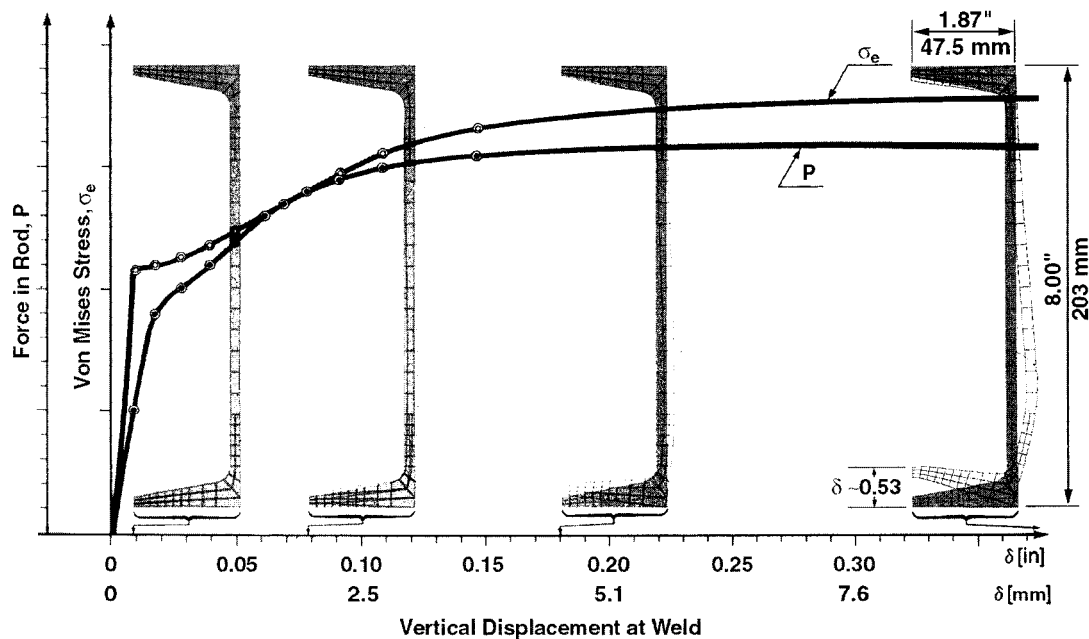
FIG. 7. Summary of FEA of Box Beam Showing Small Displacement at Large Plastic Deformations

parent from the summary of the finite-element study by the writers of this paper presented in Fig. 7. At the dead load level the plastic deformation of the channel flanges of 3–6 mm (0.10–0.15 in.) was present. This magnitude of deformation could not be observed without disassembling the connection and measuring the deformation against a straight edge. Observation was impractical, since the steel construction was covered by finish and fireproofing.

Both the experimental and analytical studies showed minimal impact on the ultimate capacity of the connection by the weld size in the as-configured construction detail. The finite-element analysis showed the importance of the channel flange stiffness to the stresses that led to the failure. The obvious indication is that the addition of a plate between the flanges of the channels and the washer could have successfully addressed this problem by stiffening the channel bottom.
