# STRUCTURAL FAILURES AND ENGINEERING ETHICS

By W. M. Kim Roddis,<sup>1</sup> Member, ASCE

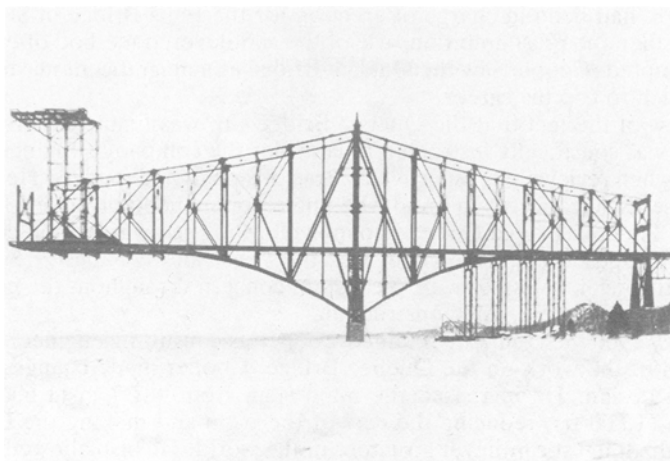
**FIG. 1. Quebec Bridge: South Anchor and Cantilever Arms Complete (Photo Courtesy Smithsonian Institution, National Museum of American History)**

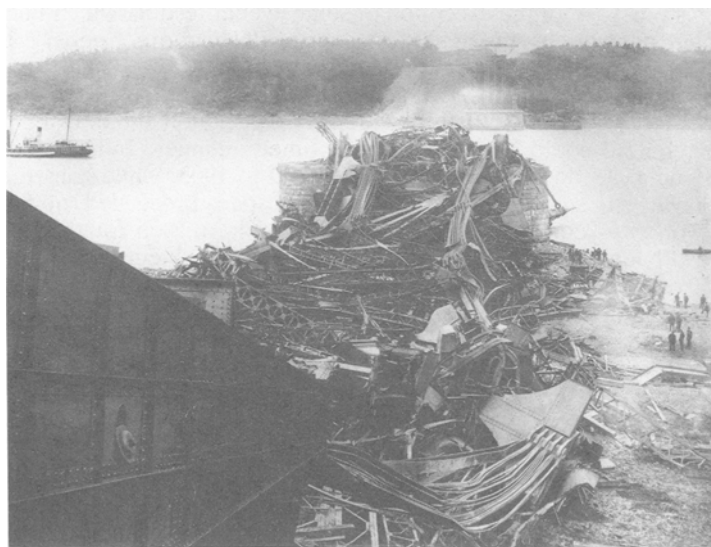
**FIG. 2. Quebec Bridge: Aftermath of Collapse (Photo Courtesy Smithsonian Institution, National Museum of American History)**

The technical cause of the Quebec Bridge collapse as established by the Royal Commission of Inquiry (*Quebec* 1908) was the failure of two compression chords. The east and west compression chords (members A9L and A9R) of the anchor arm in the second shoreward panel from the south pier failed virtually simultaneously. The chords, designed to carry a load of 97,900 kN (22,000 kips) were built-up sections with overall dimensions approximately 1.37 m (4.5 ft) deep and 1.68 m (5.5 ft) wide. Four massive vertical plate webs were each made up of four rolled plates, stitch-riveted together to form one built-up plate almost 101.6 mm (4 in.) thick. The middle plates were spaced about 0.31 m (1 ft) apart with the outer plates spaced almost 0.61 m (2 ft) from the inner plates. Lattice angles were riveted across the top and bottom faces of the built-up member in a double-lacing X pattern. The lacing was intended to tie the compression member together into a single element so that the compressive buckling strength could be based on the geometric stiffness of the integrated elements, rather than the vastly smaller buckling strength of the web plates acting individually. The 12.6-kg/m (8.5 lb/ft) angles used for the latticing were inadequate to preclude buckling of the individual column elements on a member with a cross section of 0.504 m<sup>2</sup> (781 sq in.) weighing 3,959 kg/m (2,658 lb/ft) ("The Quebec" 1907). These compression members failed, either by rupture of their latticing or shearing of their lattice rivets. The design of the latticing for these massive members was based on empirical formulas based on column tests conducted

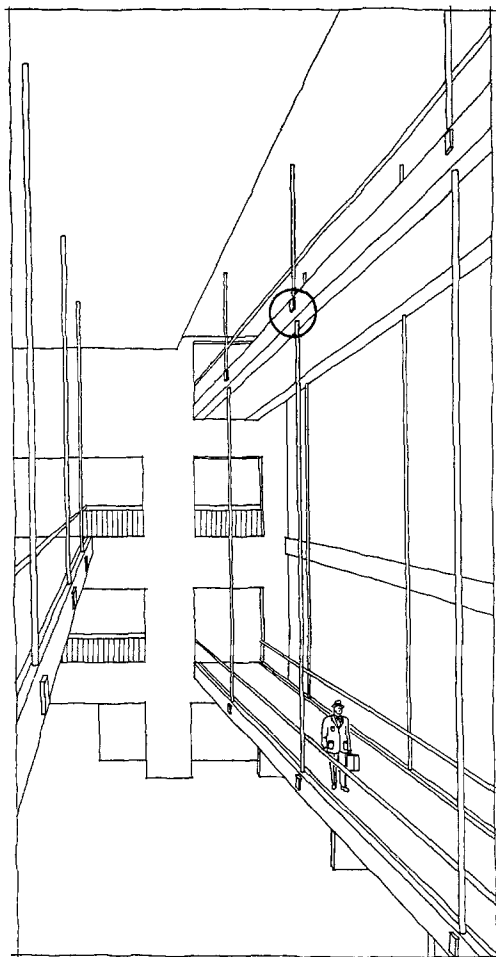
**FIG. 3. Kansas City Hyatt Regency Hotel: Schematic of Walkways as Viewed from North Wall of Atrium [Courtesy National Institute of Standards and Technology (Marshall et al. 1982)]**

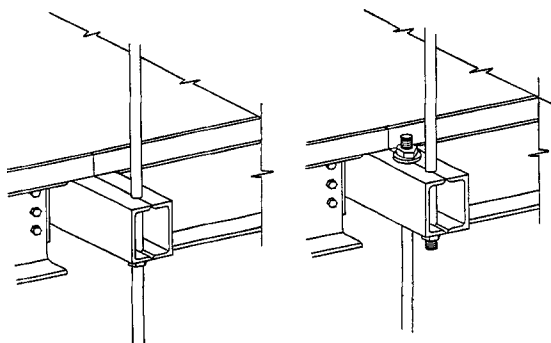
The hanger rods were connected to box sections that were the cross beams of the walkway floor framing. The original configuration of this connection is shown in Fig. 4 on the left as a continuous single-rod connection. These box sections were made of channel sections placed toe to toe. The structural drawings for the walkways show a detail of the box-beam-hanger-rod connection. The rod passed through the centerline of the box beam. The load from the box beam was transferred into the rod by a nut on the rod below the box beam. The rod was shown threaded to accommodate this nut. No loads are shown on this connection detail nor on its accompanying framing plans. Since no loads were given, the detailer interpreted this connection as a special connection designed by the structural engineer and copied the configuration shown on the structural drawing detail to the shop drawings with the addition of a standard nut and washer and a minimum weld to hold the channels in alignment for erection. This connection as detailed used no bearing plates or stiffeners and was inadequate to meet the requirements of the Kansas City building code.

**FIG. 4. Kansas City Hyatt Regency Hotel: Comparison of Continuous and Interrupted Hanger-Rod Details [Courtesy National Institute of Standards and Technology (Marshall et al. 1982)]**

drawings. In the course of detailing the steel for the atrium, questions arose as to the connection of the rod at the fourth floor and whether the rod must be continuous. After telephone conversations between the structural engineer, the fabricator, and the detailer, a change was made in the fourth-floor hanger rod to box-beam connection from a one-rod to a two-rod arrangement. The revised configuration of this connection is shown in Fig. 4 on the right as an interrupted two-rod connection. This change essentially doubled the load that had to be transferred from the box beam into the upper-hanger rod at the fourth-floor walkway connection. The shop drawings were prepared using this two-rod configuration, and the unassembled components of the connection were shown on the shop drawings. No sketch was included on the shop drawings of the assembled connection in its revised form. The shop drawings were sent to the structural engineer for review and approval. The structural engineer did not review the revised detail for conformity with the design concept nor for compliance with the requirements of the Kansas City building code. The shop drawings were stamped by the structural engineer indicating review only for conformity with the design concept and compliance with the contract documents. The revised two-rod connection was structurally inadequate to support the loads imposed on it.

- The collapse initiated at a fourth-floor box-beam–hanger-rod connection.

- The loads on the walkways at the time of collapse were substantially less than the Kansas City building code specified design loads.
- The as-constructed beam-rod connection did not meet code, nor did the original (continuous rod) detail.
- The change in rod detail essentially doubled the transfer load.
- Neither quality of workmanship nor materials played a significant role in initiation of the collapse.

- The engineer of record (EOR) should have responsibility and authority for all aspects of the structural design, including the connections. Connections should either be designed or reviewed and approved by the EOR.
- The EOR should have sufficient time and compensation to prepare design drawings and to review and approve shop drawings in order to produce safe structures.
- The design drawings should provide sufficient information for the fabricator to produce correct shop drawings.
