## Columbia Gas of Massachusetts – Project Issue Analysis – AD642 Individual Assignment 2

©2020 Richard Maltzman, Master Lecturer, Boston University Metropolitan College

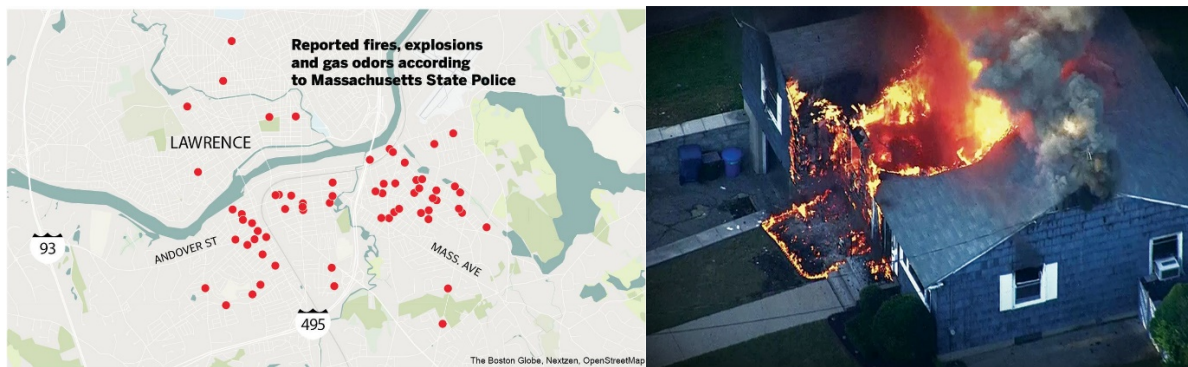
*The sensor on the discarded length of pipe thinks it’s still measuring the gas pressure in a vast underground network. In fact, it is measuring nothing: The pipe has been disconnected from the network. **The sensor might as well be attached to a hot dog.** But the sensor doesn’t know any of that, and there is no other sensor in this segment of the network to contradict it.*

*The sensor sends a message to the regulator valves in this segment of the network: Boost the pressure! Which they do. But the sensor, because it’s still attached to the dead piece of pipe,*

*doesn't detect any of that. Instead, it registers a pressure drop, all the way down to 0.01 psi. More pressure, it tells the valves, until they have opened completely, **and two distribution systems that were supposed to be segregated, cordoned off from each other, are instead tied directly into each other for twenty-six minutes.***

*A wave of high-pressure gas rushes into the regional gas-main system that serves Lawrence, Andover, and North Andover. In the older cast-iron segments of the network, the pressure rises to at least 6 psi, twelve times what the pipes are capable of handling.*

The result of this over-pressurization: 141 fires, 5 explosions, 21 serious injuries, 1 death, many people displaced and/or without heat or the ability to cook - for months, and the bankruptcy of Columbia Gas of Massachusetts.
